AN OASIS FOR RAILROADERS IN THE MOJAVE
The History and Architecture of the Los Angeles and Salt Lake Railroad Depot,
Restaurant and Employees' Hotel at Kelso, California, on the Union Pacific System

Kelso Depot Historic Structure Report

National Preserve • California

January 1998

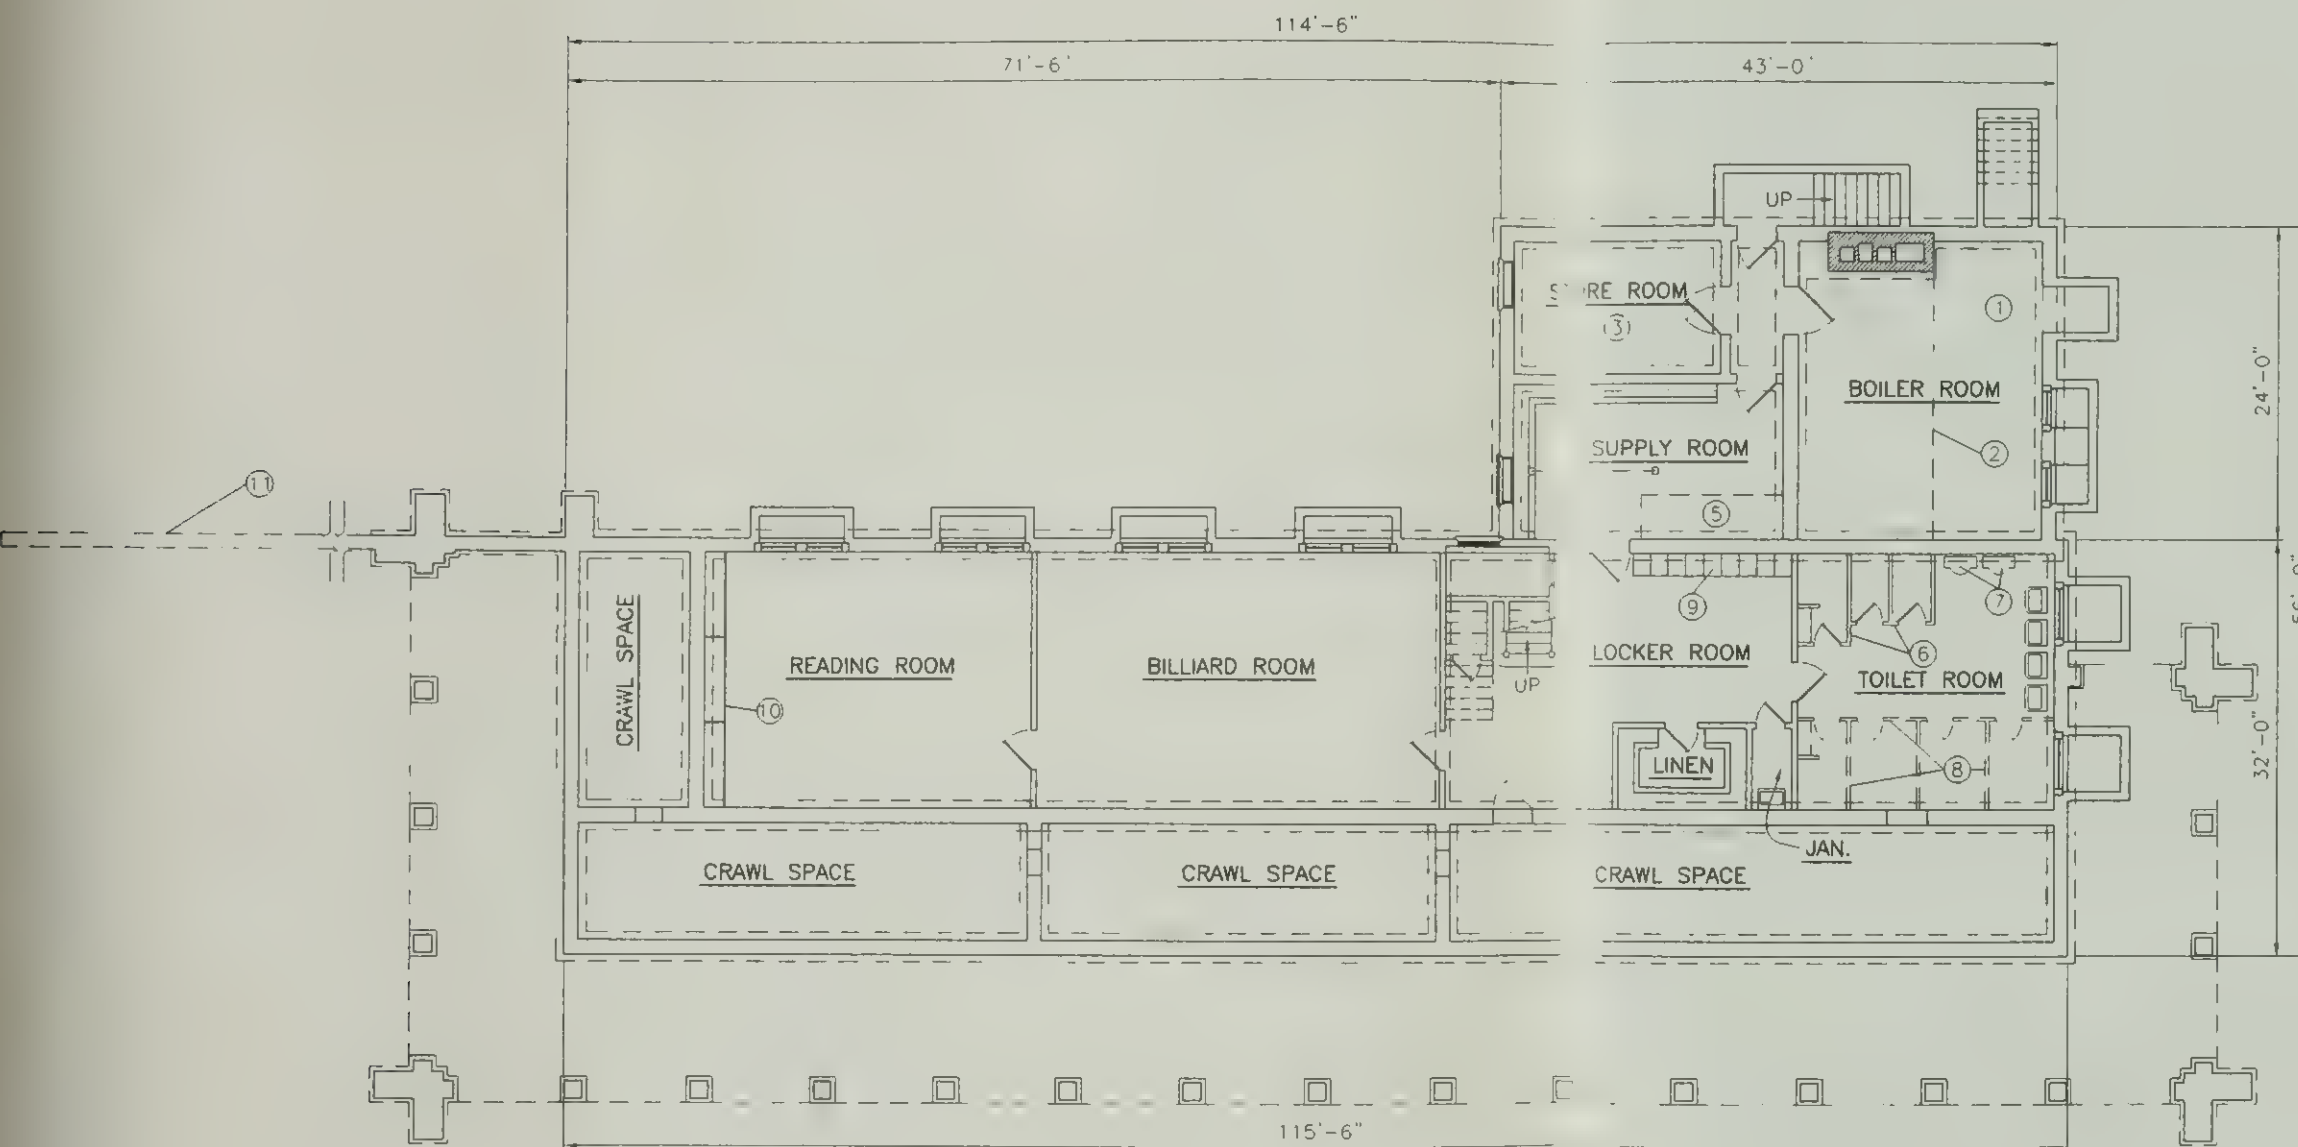
A
A1 BASEMENT PLAN

- ① ORIGINAL HEATING PLANT EQUIPMENT HAS BEEN REMOVED
- ② KITCHEN FLOOR FRAMING SUPPORT ADDED, DATE UNKNOWN COLUMN AND BEAM FROM RAILROAD TRACK RAIL
- ③ REFRIGERATION EQUIPMENT (EXTANT) INSTALLED CA 1925 & DOOR SWING CHANGED
- ④ 6x6 BEAM AND COLUMNS ADDED-- DATE UNKNOWN
- ⑤ STAIRWELL ABOVE
- ⑥ ORIGINAL SHOWER AND TOILET STALLS
- ⑦ ORIGINAL URINALS
- ⑧ ORIGINAL SHOWER AND BATHTUB STALLS REMOVED-- DATE UNKNOWN
- ⑨ ORIGINAL LOCKERS
- ⑩ ORIGINAL BOOKCASES
- ⑪ RETAINING WALL OF ORIGINAL DESIGN NOT CONSTRUCTED

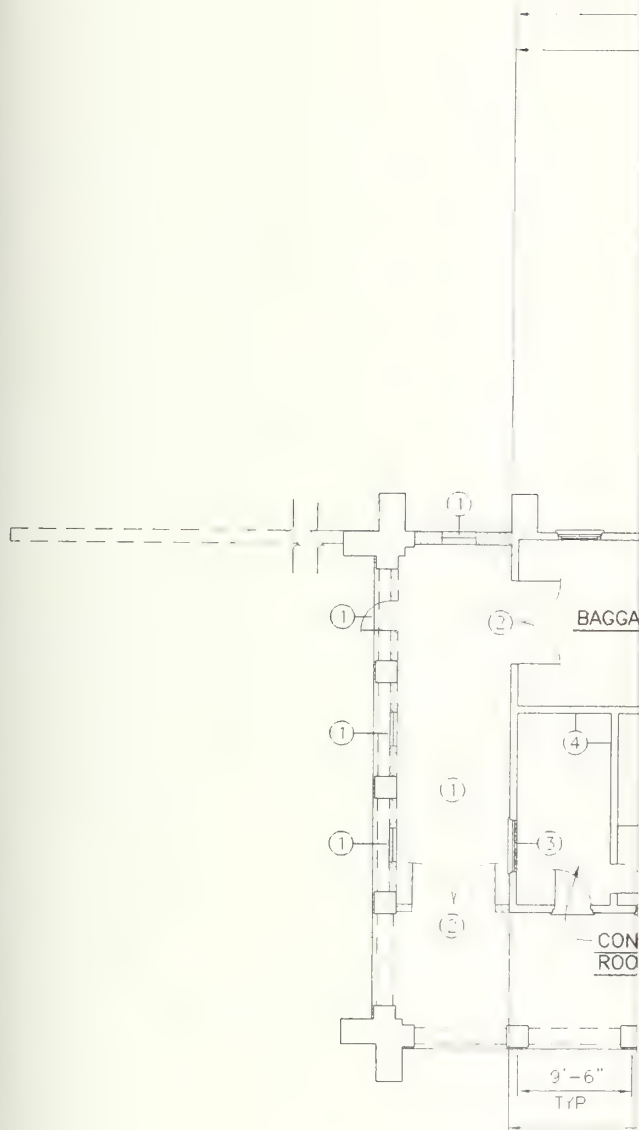
- (1) WEST ARCADE ENCLOSED, CA 1942 (DATE NOT CONFIRMED)
- (2) ORIGINAL BAGGAGE ROOM DOORS MOVED TO SOUTH END OF CA 1942 ADDITION
- (3) ORIGINAL WINDOW REMOVED, CA 1942.

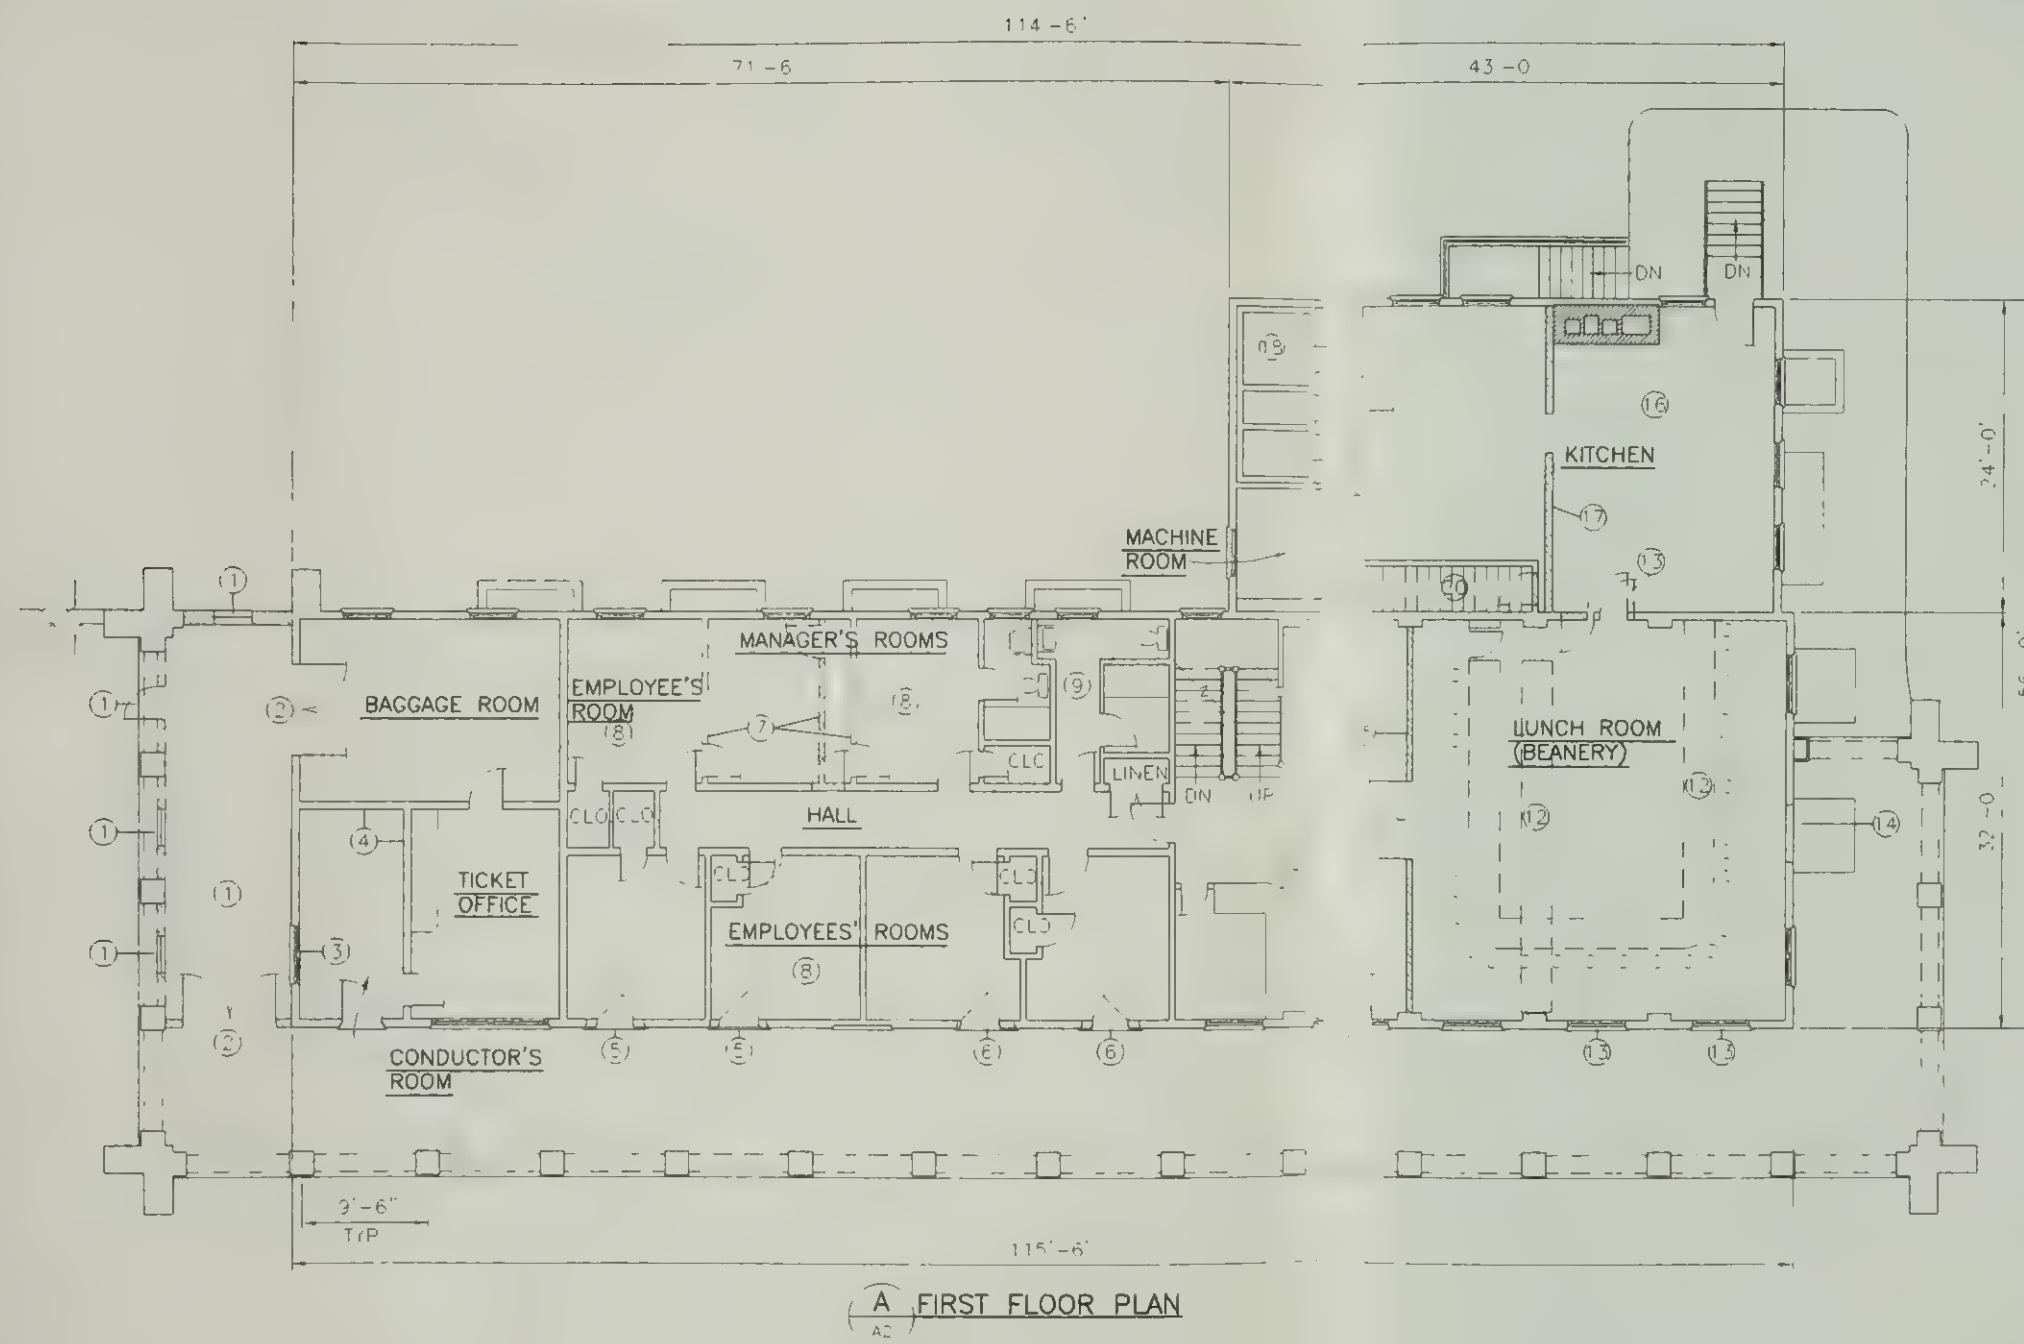
- (1) WEST ARCADE ENCLOSED, CA 1942 (DATE NOT CONFIRMED)
- (2) ORIGINAL BAGGAGE ROOM DOORS MOVED TO SOUTH END OF CA 1942 ADDITION
- (3) ORIGINAL WINDOW REMOVED, CA 1942

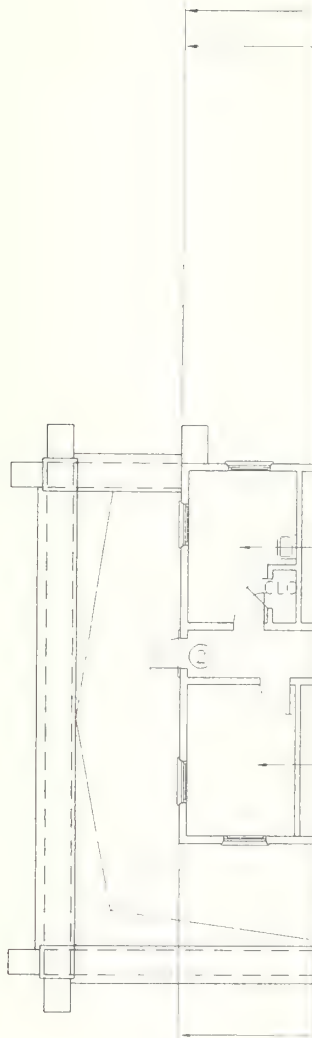
(1) FIRE SEPARATION DOORS ADDED; DATE UNKNOWN,
POSSIBLY 1960 OR 1961

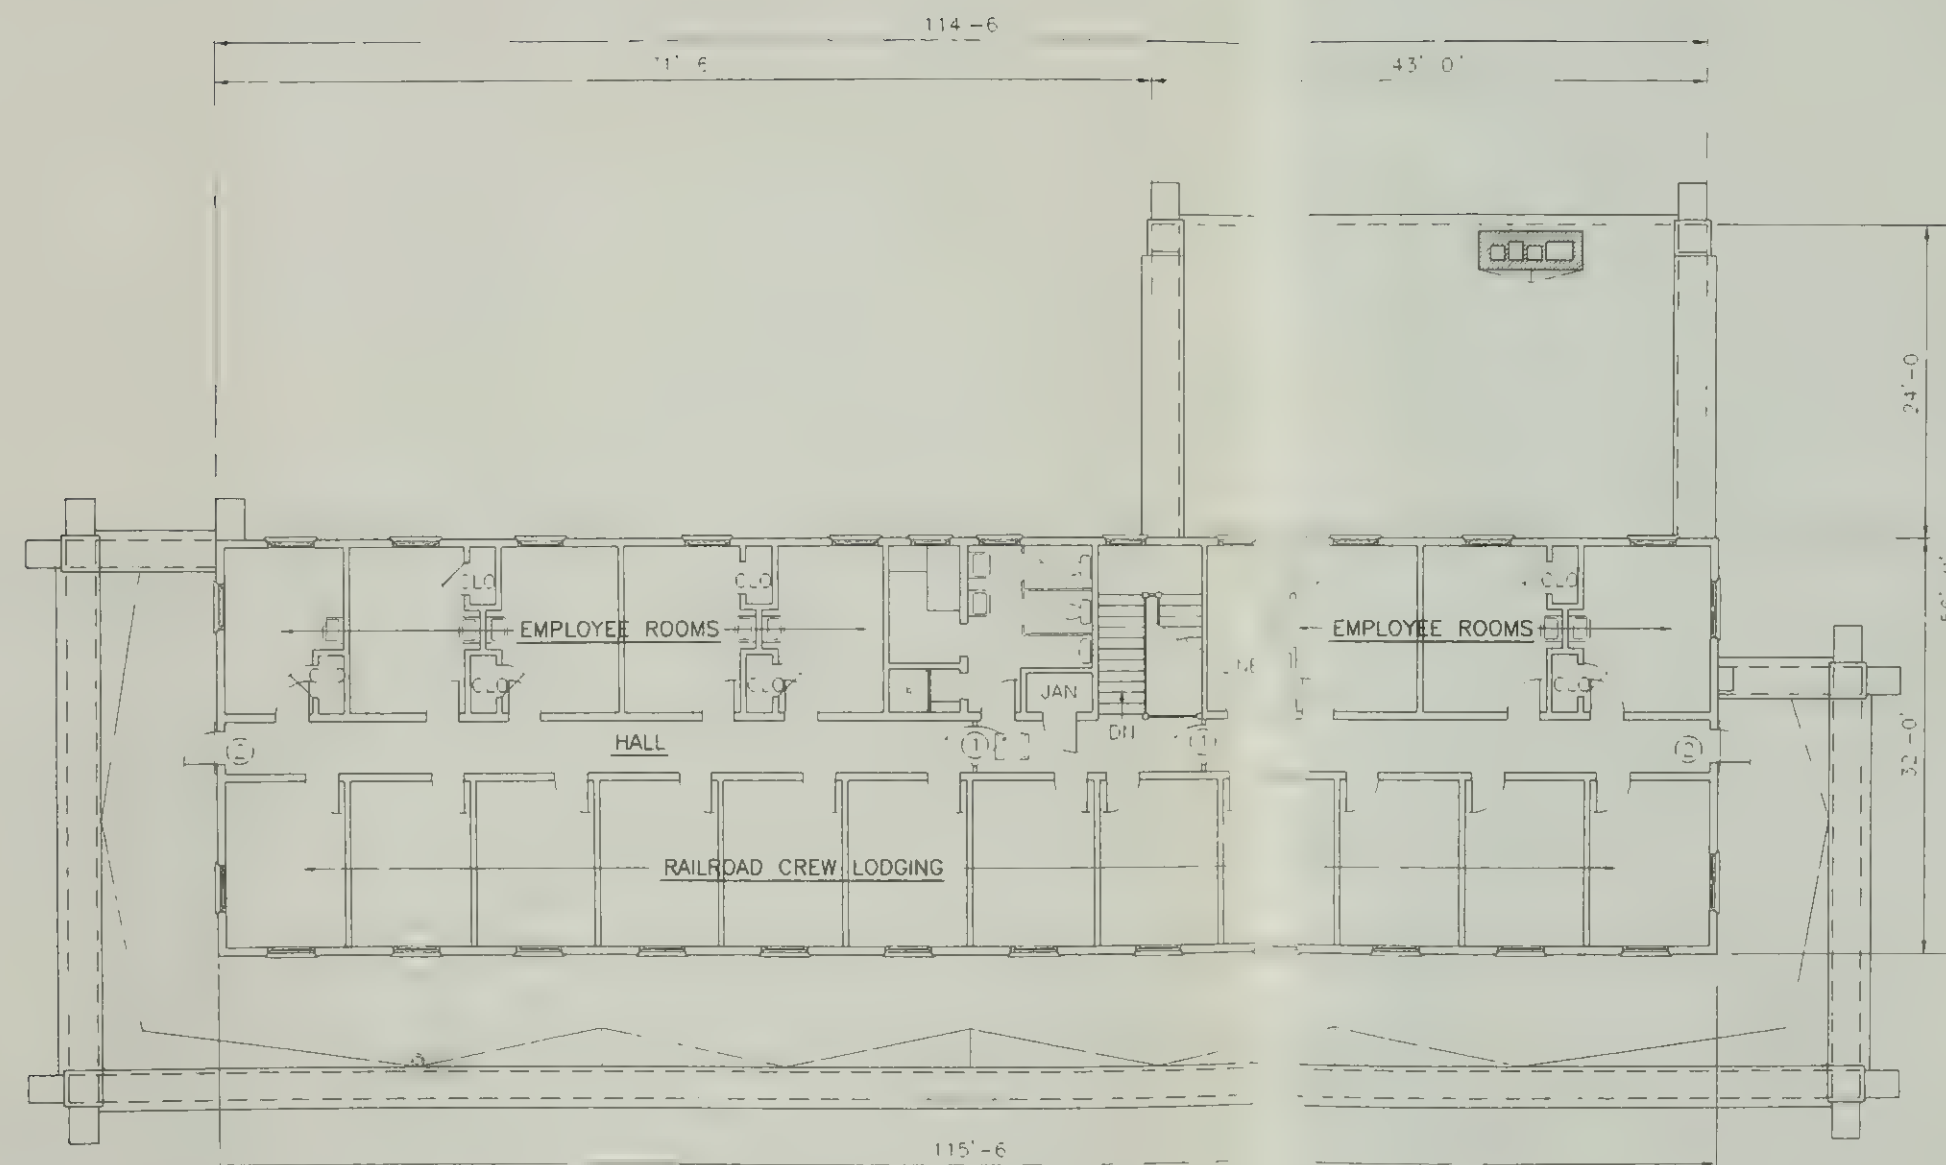
A SECOND FLOOR PLAN

- 1) FIRE SEPARATION DOORS ADDED, DATE UNKNOWN, POSSIBLY 1960 OR 1961
- 2) WINDOWS REMOVED AND REPLACED WITH DOORS FOR FIRE ESCAPES 1960 & 1961

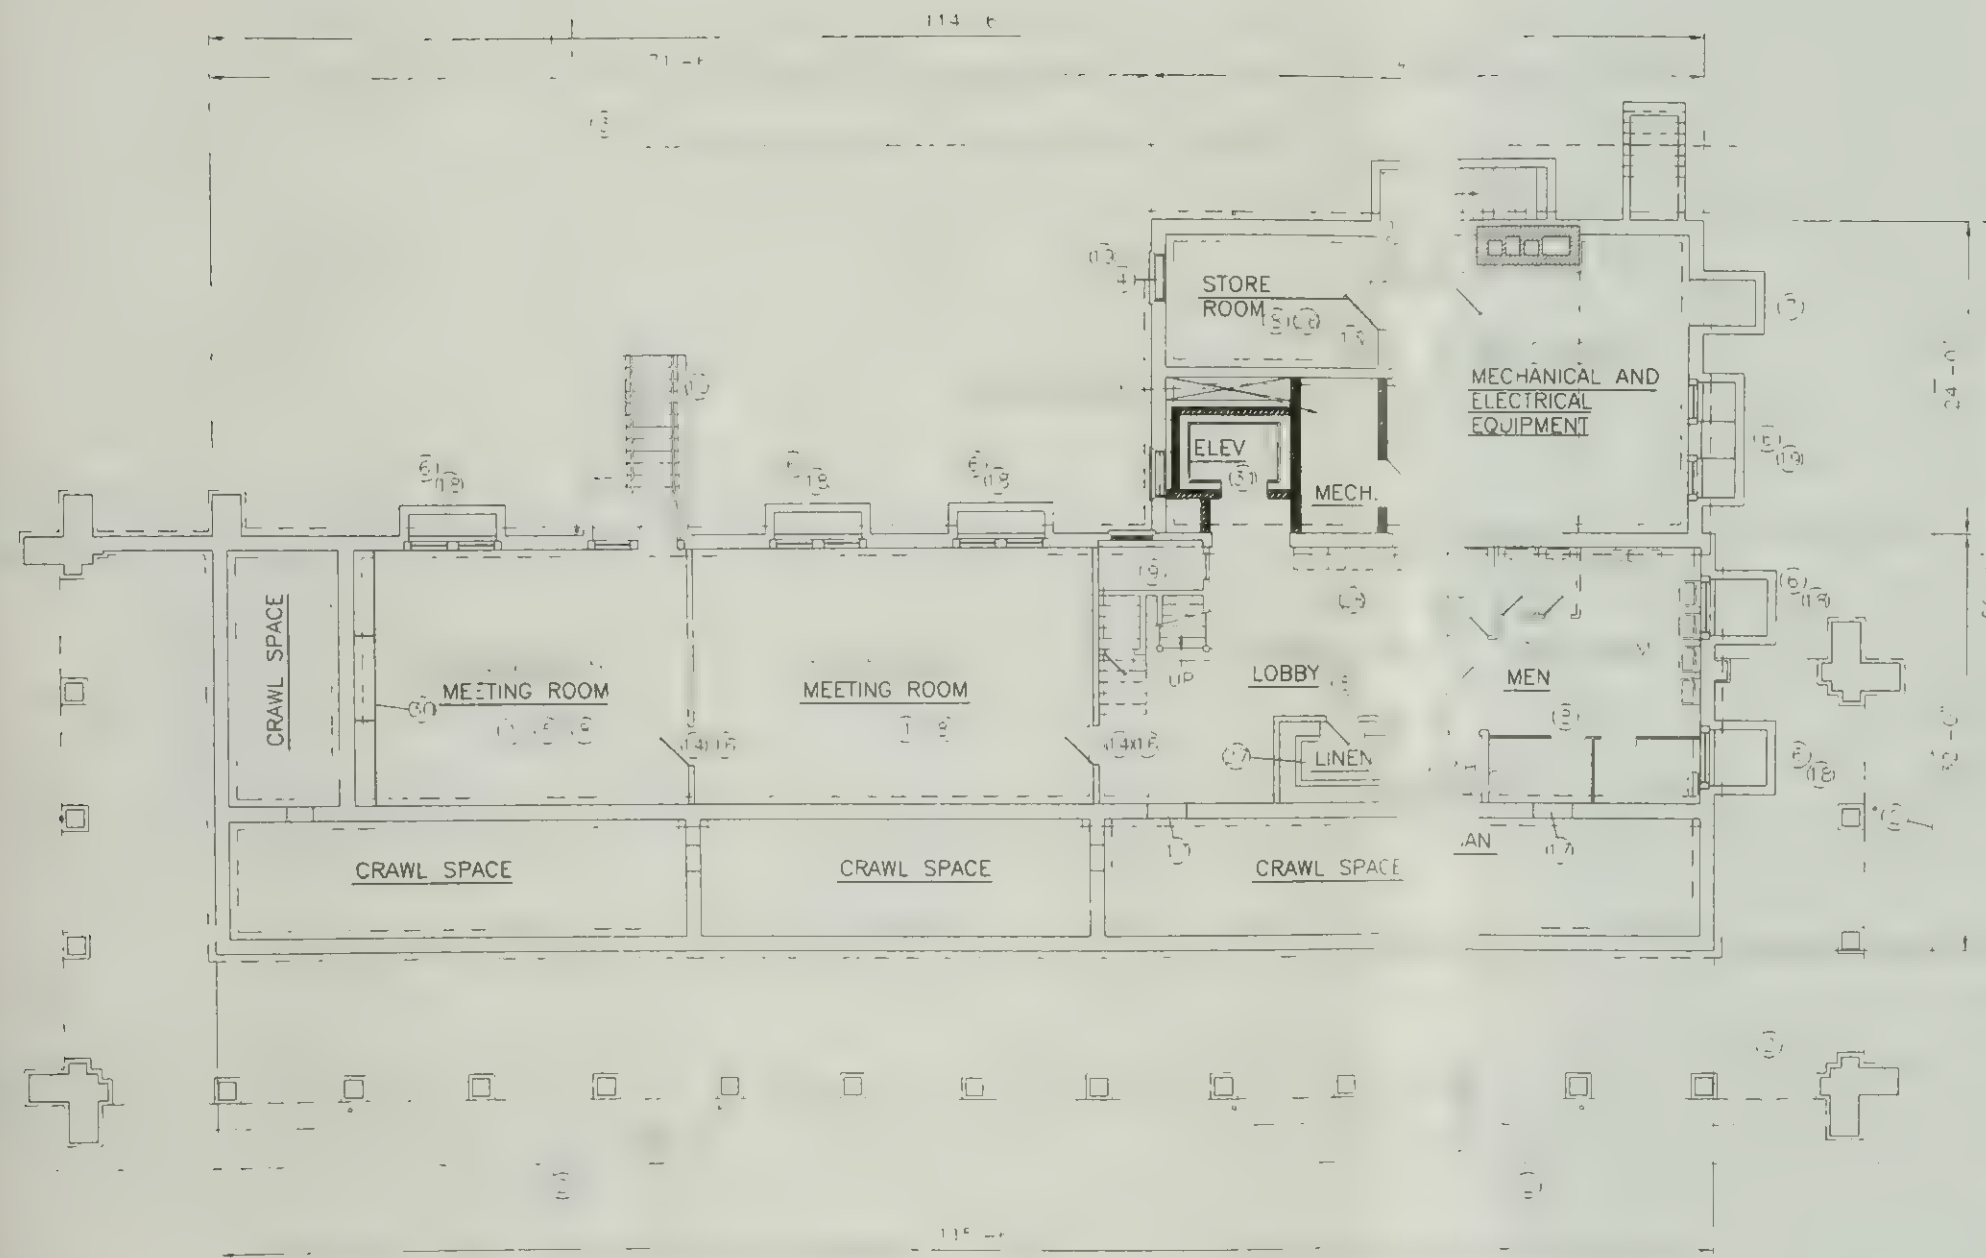
A BASEMENT PLAN

- (1) REMOVE (E) ADDITIONAL CEILING SYSTEM
- (2) REMOVE OR CAP (E) STORM DRAINS AT FRONT OF BUILDING AND UNDER APRON AND INSTALL (N) DRAINS OUTSIDE BUILDING PERMETER REPAIR OR REPLACE REMAINDER OF LOOP
- (3) REPAIR STORM WATER SEWER
- (4) REPLACE CONCRETE STEM WALL WINDOW JUNCT
- (5) REPAIR OR REPLACE CONCRETE SLAB AT UNSAFE CRACK OFFSET MATCH ORIGINAL COLOR AND COEFFICIENT
- (6) REPAIR AND REFINISH (E) AREAWAY GRADES AS REQUIRED REPLACE MISSING GRATES REPLACE CRATE TO FREEZE
- (7) REPLACE STEEL HAT H COVER
- (8) STRENGTHEN FIRST FLOOR FRAMING ABOVE INSTALL CONNECTORS, BLOCKING, AND BRIDGING AS REQUIRED
- (9) REINFORCE STAIR LANDINGS REPAIR (E) STAIR COMPONENTS AS REQUIRED AND REFINISH
- (10) NEW EMERGENCY EXIT
- (11) INSULATE EXTERIOR FRAME WALLS

- (12) REPAIR AND REFINISH EXISTING
- (13) REPLACE MISSING DOORS OR DOORS WITH MORE THAN 50% DAMAGE
- (14) WHEN OPENING TO 36" AND PROVIDE (N) FRAME, DOOR, AND TRIM WITH CONFIGURATION AND MOLDINGS DIFFERENT THAN BUT COMPATIBLE WITH HISTORIC PROVIDE ACCESSIBLE HARDWARE
- (15) PRESERVE HISTORIC HARDWARE
- (16) PROVIDE ACCESSIBLE HARDWARE USE HISTORIC HINGES WHERE POSSIBLE
- (17) NEW ACCESS DOOR

- (18) REPAIR RE-GLAZE AND REFINISH EXISTING REPLACE MISSING AND BROKEN GLASS
- (19) REPLACE MISSING WINDOWS OR WINDOWS WITH MORE THAN 50% DAMAGE
- (20) REHABILITATE (E) HARDWARE REPLACE MISSING AND DAMAGED HARDWARE TO MATCH HISTORIC

- (21) REPLACE MISSING AND DETERIORATED CEILING AND WALL PLASTER MATCH HISTORIC TEXTURES
- (22) REMOVE AND REPLACE ALL CEILING AND WALL PLASTER REQUIRED FOR STRUCTURAL, MECHANICAL, AND ELECTRICAL WORK MATCH HISTORIC TEXTURES
- (23) REINSTALL OR REPAIR WOOD TRIMS, REPLACE MISSING AND DETERIORATED TRIMS, MATCH HISTORIC PROFILES
- (24) REPAINT CEILINGS AND WALLS
- (25) RESTORE NATURAL WOOD FINISHES

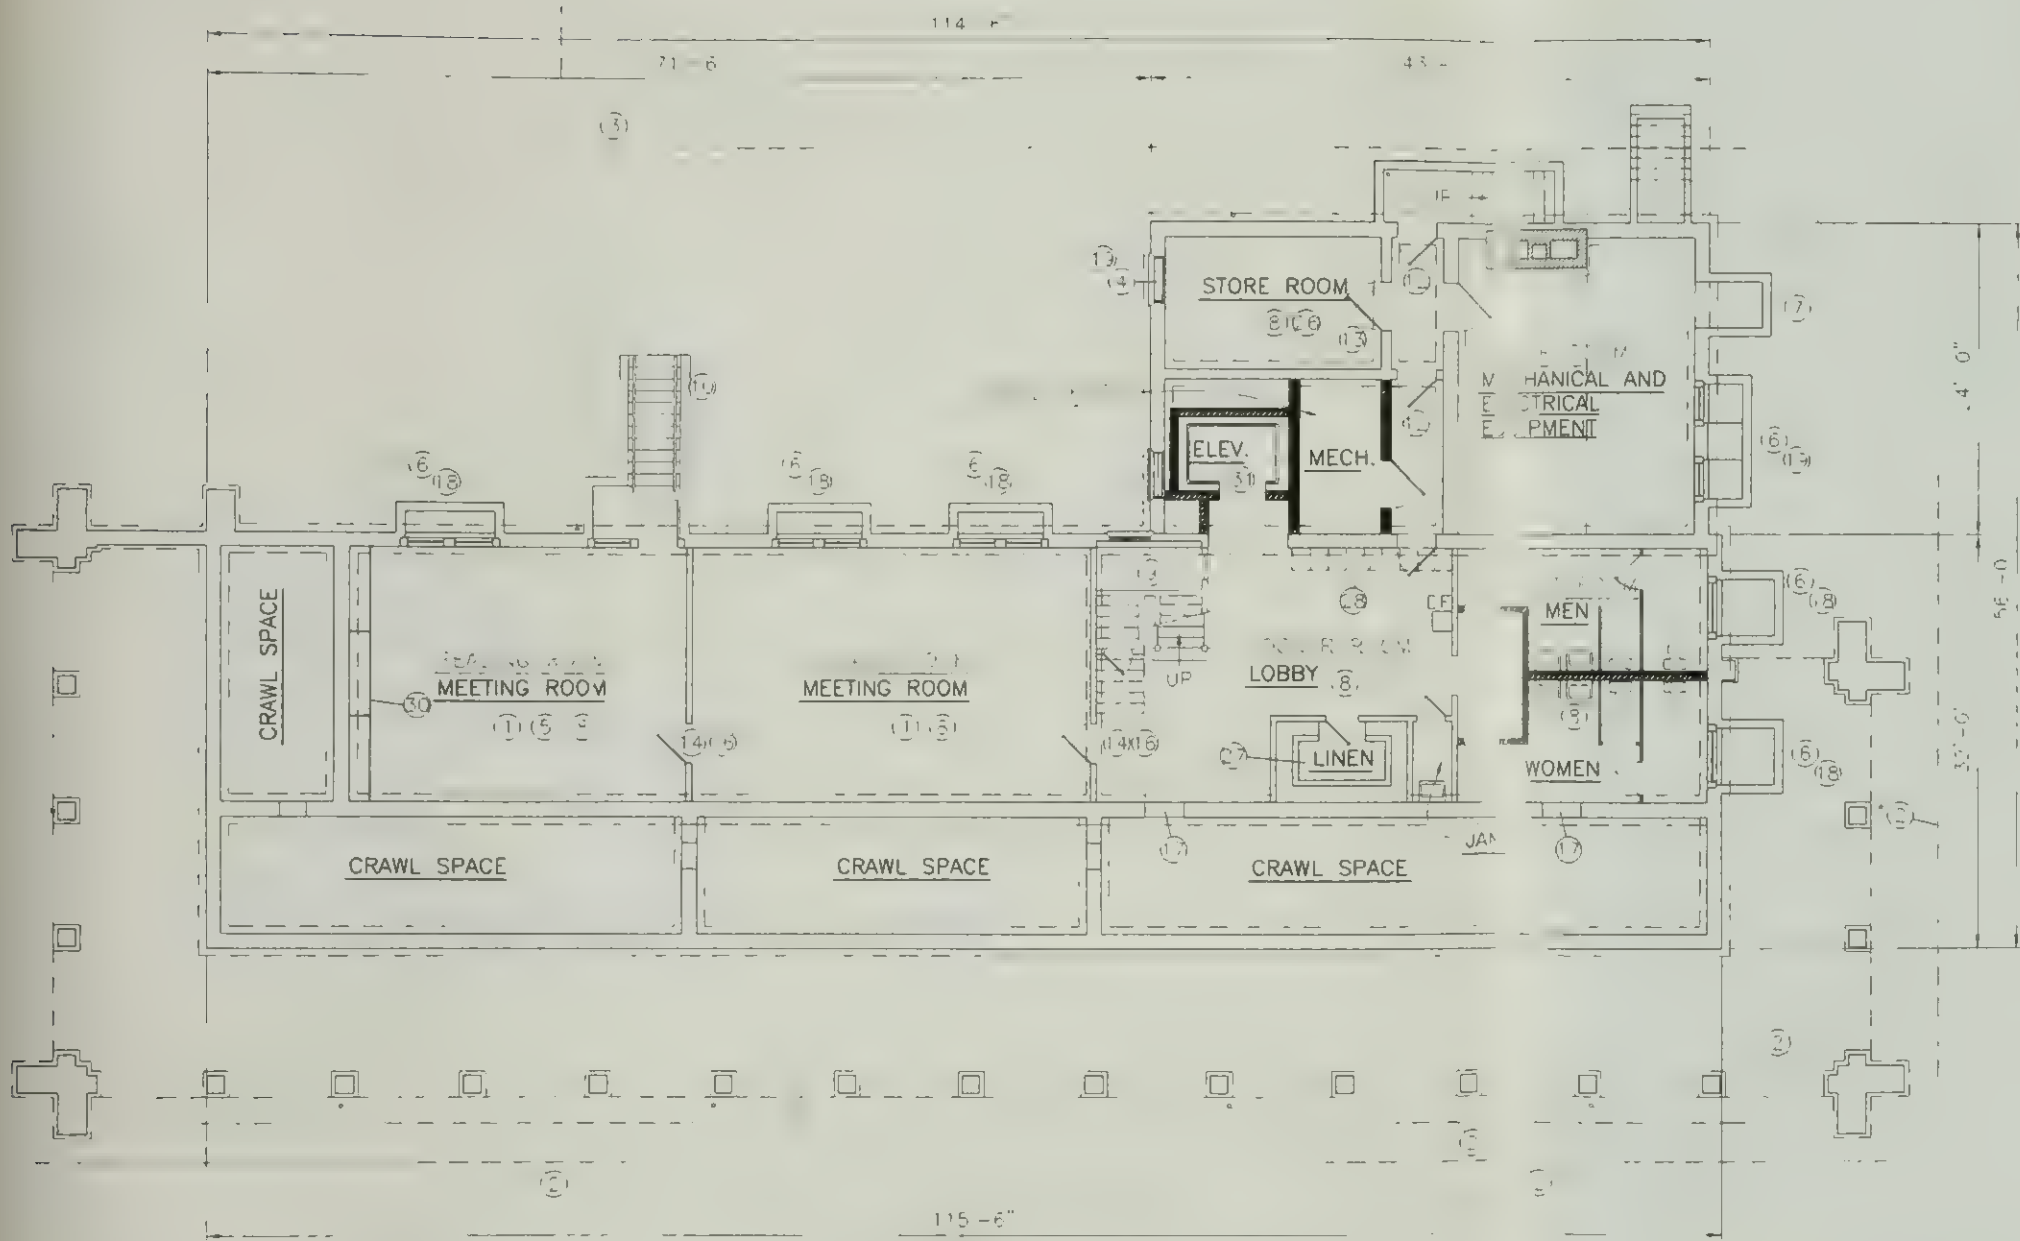
A BASEMENT PLAN

- (1) REMOVE (E) ACOUSTICAL CEILING SYSTEM
- (2) REMOVE OR CAP (E) STORM DRAINS AT FRONT OF BUILDING AND UNDER ARCADE AND INSTALL (N) DRAINS OUTSIDE BUILDING PERIMETER REPAIR OR REPLACE REMAINDER OF LOOP
- (3) REPAIR STORM WATER SEWER
- (4) REPLACE CONCRETE STEM WALL WINDOW LINTEL
- (5) REPAIR OR REPLACE CONCRETE SLAB AT UNSAFE CRACK OFFSET MATCH ORIGINAL COLOR AND SCORING
- (6) REPAIR AND REPAINT (E) AREAWAY GRATES AS REQUIRED REPLACE MISSING GRATES REPLACE GRATE SCREENS
- (7) REPLACE STEEL HATCH COVER
- (8) STRENGTHEN FIRST FLOOR FRAMING ABOVE INSTALL CONNECTORS, BLOCKING, AND BRIDGING AS REQUIRED
- (9) REINFORCE STAIR LANDING REPAIR (E) STAIR COMPONENTS AS REQUIRED AND REFINISH
- (10) (N) EMERGENCY EXIT
- (11) INSULATE EXTERIOR FRAME WALLS

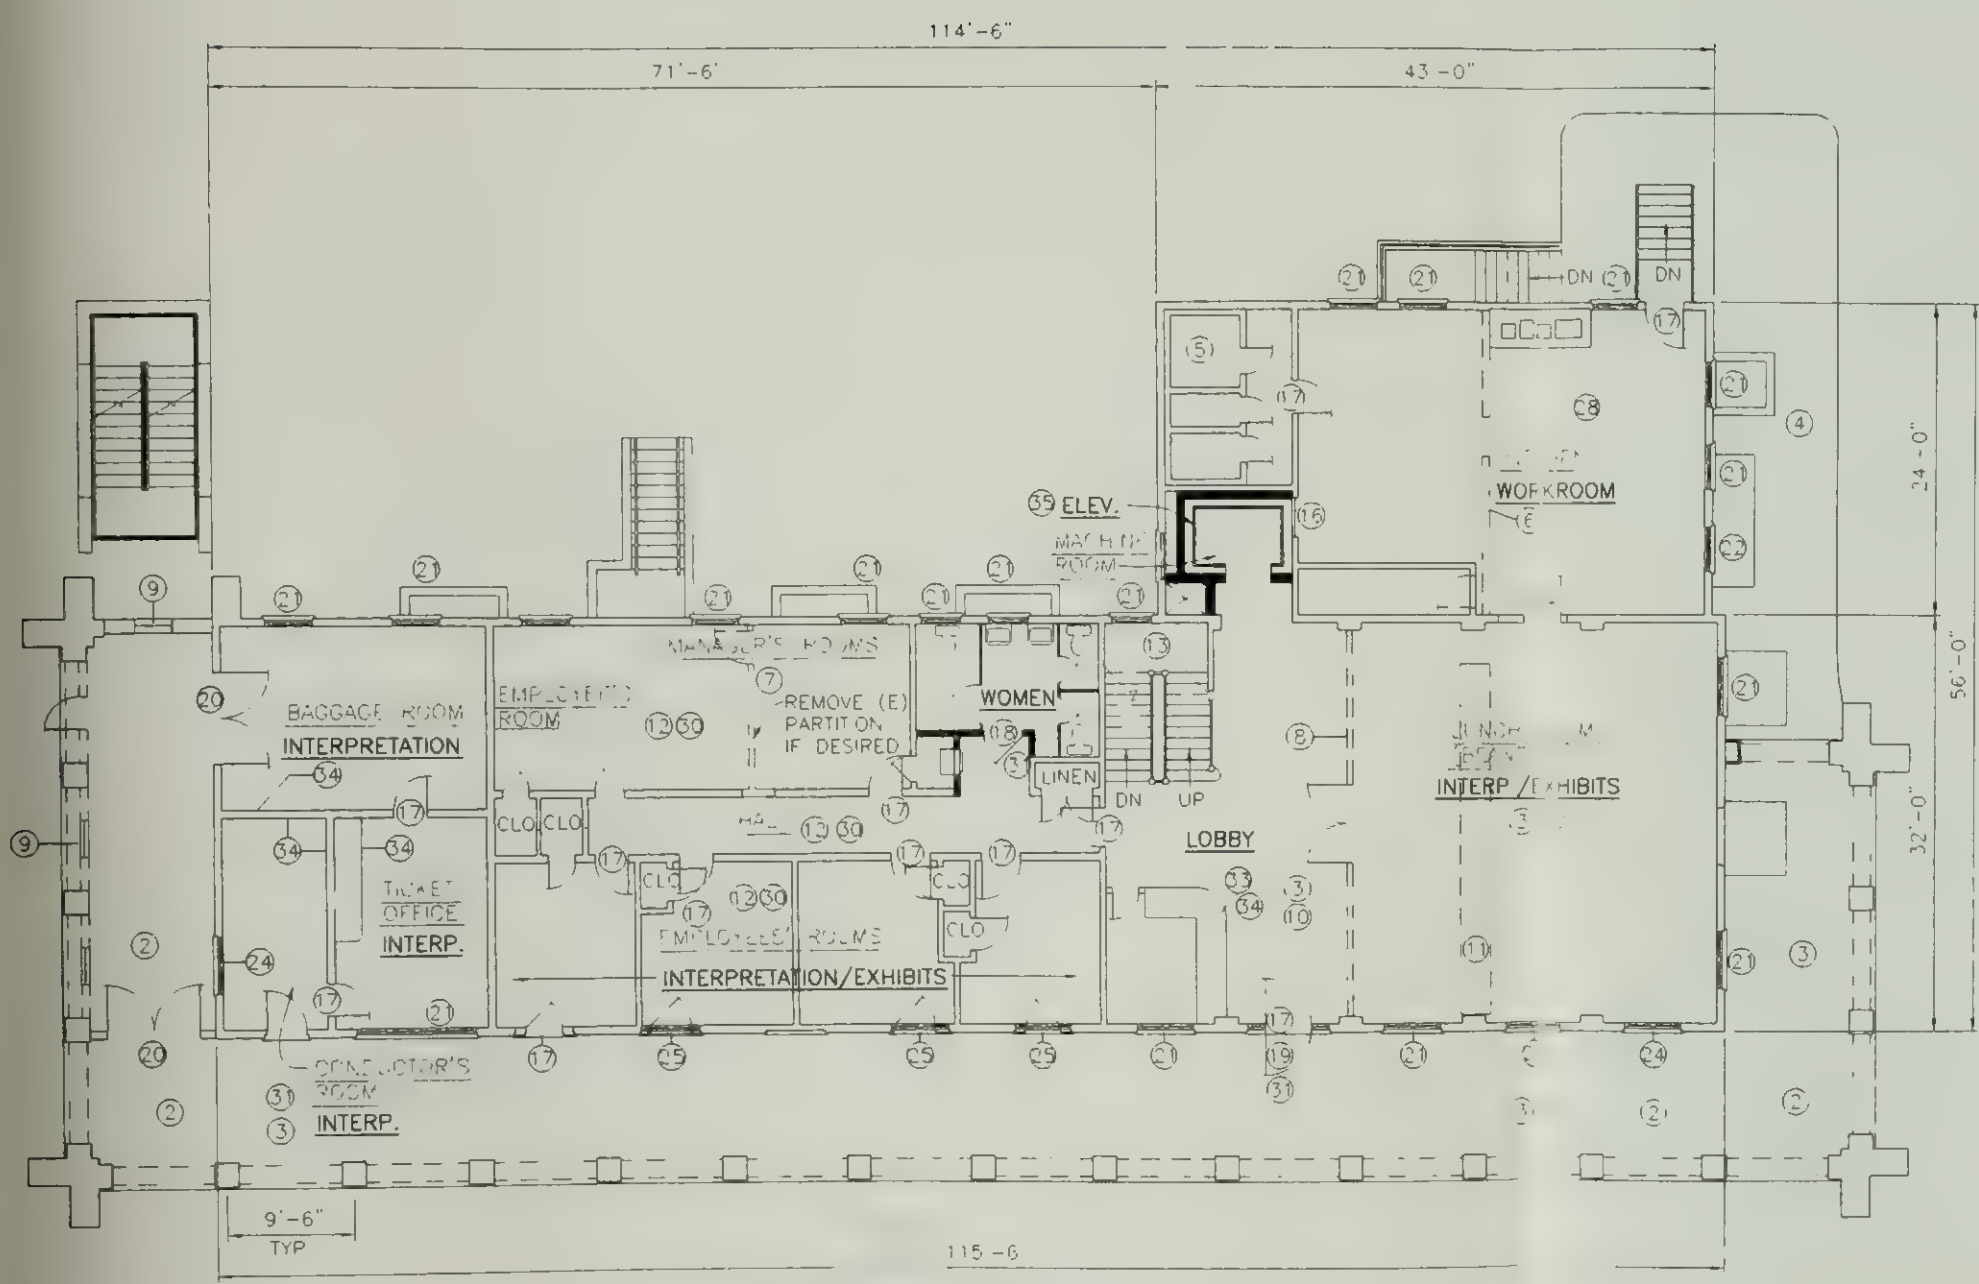
A FIRST FLOOR PLAN
46

- ㉟ ALL NEW POWER LIGHTING, CONTROL FIRE AND INTRUSION DETECTION, TELEPHONE, DATA, COMMUNICATIONS, AND TV SYSTEMS

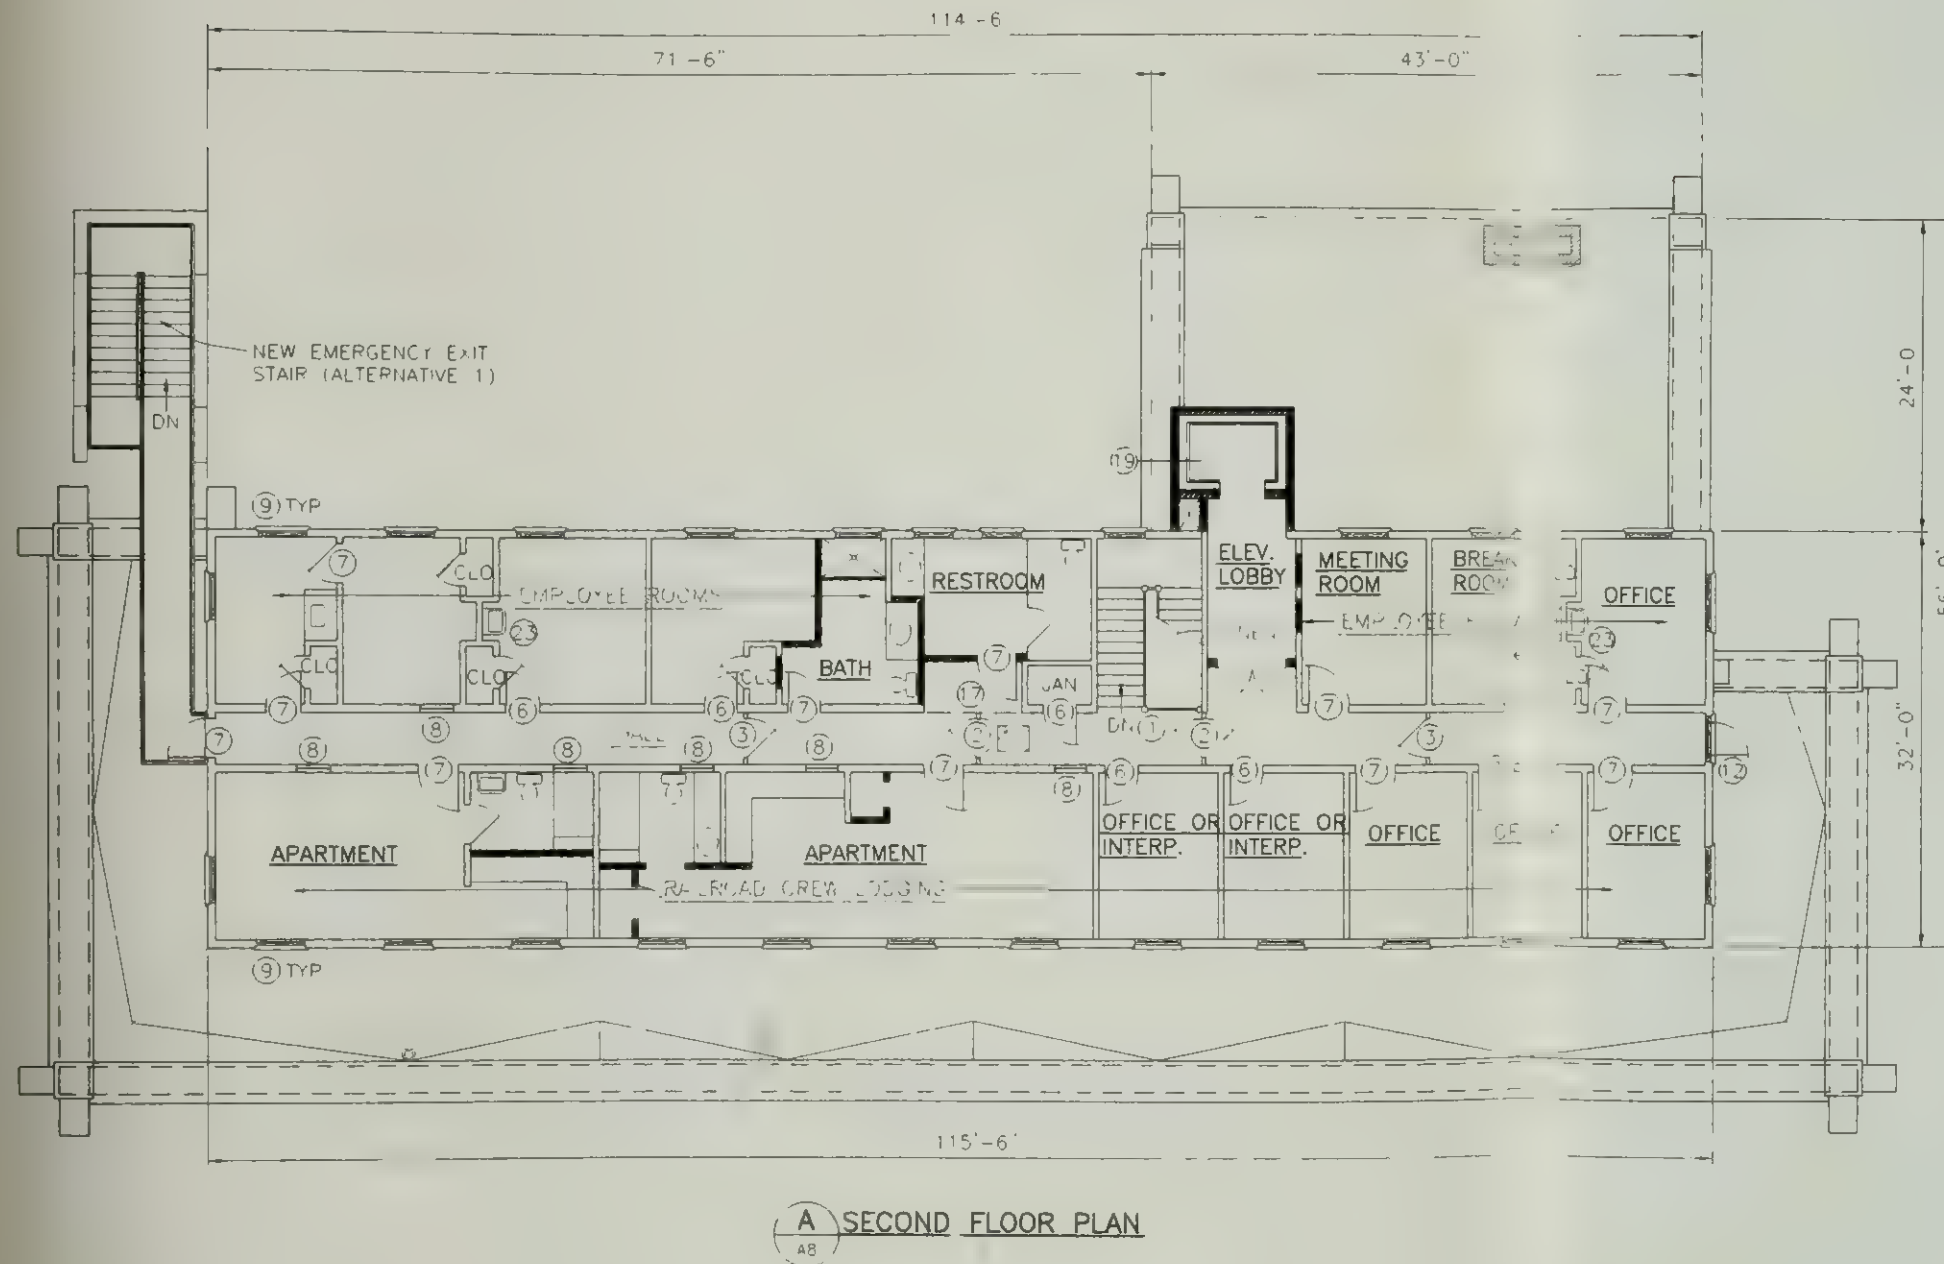
- ① RESTORE AND REFINISH HISTORIC STAIR
- ② REMOVE (E) HALLWAY FIRE SEPARATION DOORS AND PARTITION
- ③ (N) FIRE RATED SEPARATION PARTITIONS AND DOORS WITH AUTOMATIC CLOSERS
- ④ INSTALL STRUCTURAL BRACING, LOAD TRANSFER CONNECTORS, BLOCKS AND BRIDGING IN ATTIC AND SECOND STORY
- ⑤ INSULATE SECOND STORY CEILING AND EXTERIOR WALLS

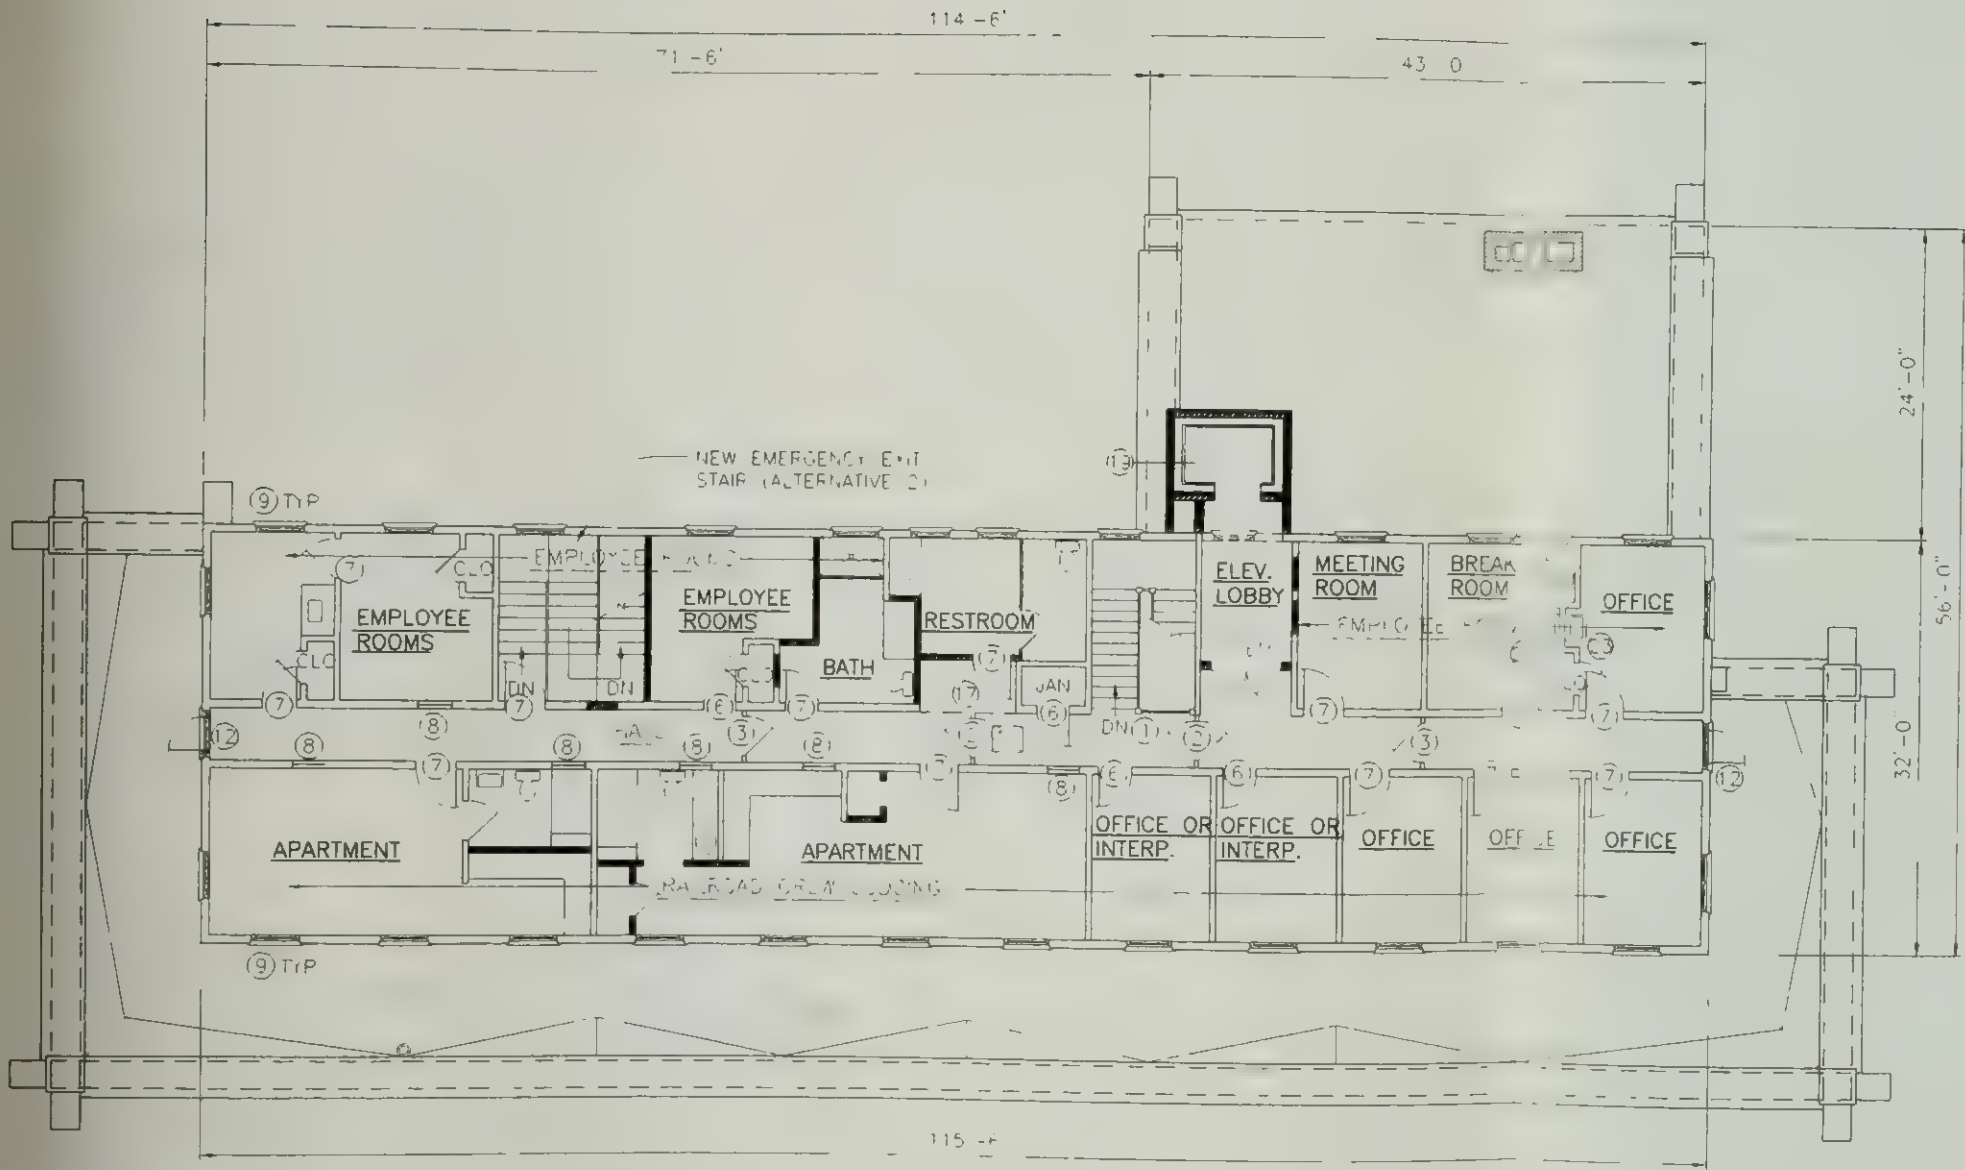
A SECOND FLOOR PLAN

- GENERAL**
- (1) RESTORE AND REFINISH HISTORIC STAIR
 - (2) REMOVE (E) HALLWAY FIRE SEPARATION DOORS AND PARTITION
 - (3) (IN) FIRE RATED SEPARATION PARTITIONS AND DOORS WITH AUTOMATIC CLOSERS.
